PILOTNÝ PROJEKT - NÁRODNÁ TRIEDA Č. 41-45, KOŠICE

Within the scope of science-technical project VTP 6 - 400 "Upgrading of buildings with emphasis to housing stock" has been realized *the pilot project Národná trieda No. 41-45, Košice* intent on the dwelling house upgrading, including the reduction of heat consumption for heating and construction of new dwellings in the roof superstructure.

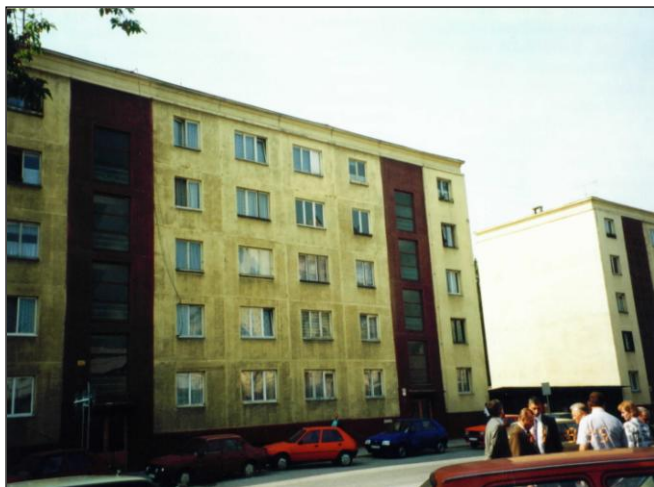
▲ Pôvodný stav bytového domu
Original Condition of the Dwelling House

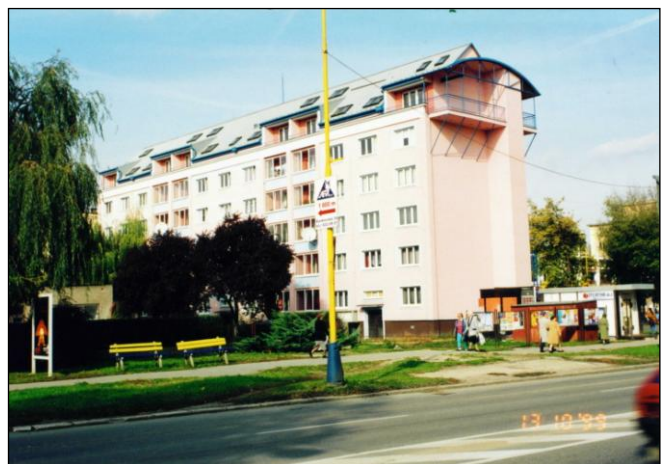
▲ Nový stav bytového domu so zasklenými lodžiami New condition of the dwelling House with glazed loggias

- zasklenie lodžii - oproti projektu realizátor zmenil jednoduché zasklenie na izolačné dvojsklo v plastových rámoch.

- glazing of loggias - the supplier of realization works changed, in comparison with design, a single glazing for an insulating double-glass in plastic frames.

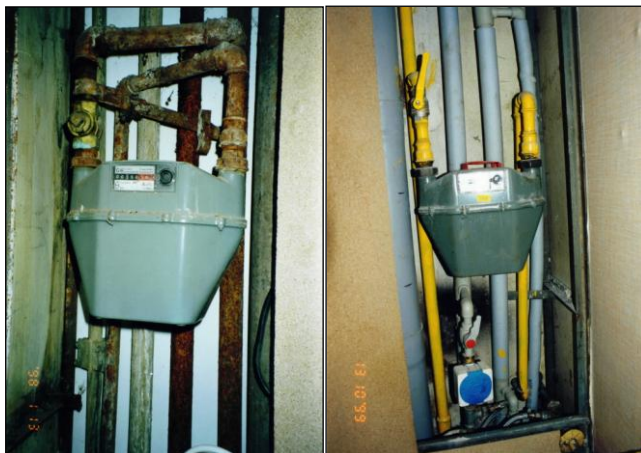
▲ Pôvodné inštaláčnne rozvody a po obnove
Original installation distribution lines and after their upgrading

- replacement of installation distribution lines for gas - original distribution lines made of black steel with the threaded joints (though they didn't get over the end of their service life, but in regard of the flooding caused by users several times during the dwelling house existence, they were completely corroded in the passages through the ceiling plate) were replaced by new ones;

- výmena inštaláčnych rozvodov v bytových jadrách (výmena stúpacích potrubí studenej vody, teplej úžitkovej vody a cirkulácie za potrubia z polypropylénových rúr HOSTALEN bola vykonaná z prefabrikovaných dielov, spájaných polyfúznym zvarovaním a tlakovo odskúšaných);
- výmena plynoinštaláčnych rozvodov - pôvodné rozvody z čiernej ocele so skrutkovými spojmi (síce nedosiahli koniec svojej životnosti, ale vzhľadom na niekoľkonásobné vytopenie užívateľmi počas existencie bytového domu, boli úplne skorodované v prechodoch cez stropnú dosku) boli vymenené za nové;

replacement of installation distribution lines in the sanitary blocks (replacement of the upward pipelines of cold water, hot utility water and circulation by the pipelines made of HOSTALEN polypropylene tubes was carried out by means of prefabricated parts, joined by the polyfusion welding and by pressure tested);

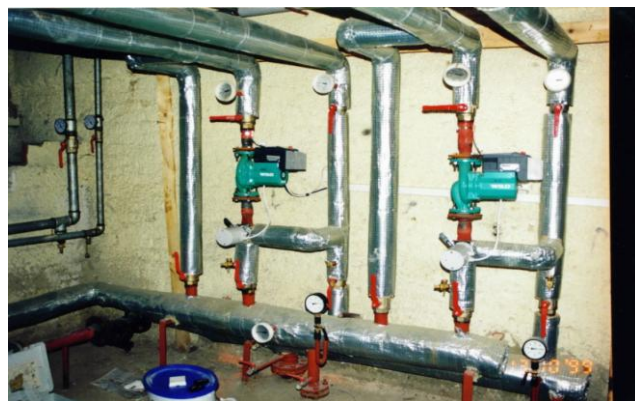
▲ Strojovňa výmenikovej stanice
Machinery-room of the heat exchanger station

za delený horizontálny systém rozvodov - zónová regulácia. Pretože budova je tepelne napojená na sídliskovú kotolňu s ekvitermickou reguláciou teplej vody, systém bol nadimenzovaný a zrealizovaný na znížené parametre, ktorými je zabezpečená hydraulická stabilita systému (zamedzenie nedokurovania a prekurovania spodných/horných podlaží). Osadené sú dve zmiešavacie armatúry pre zónovú reguláciu (sever, juh) MIX AP, DN 40 s elektropohonom. Vzhľadom na riešenie vykurovacieho systému zónovou reguláciou nebolo na vykurovacích telesách použité termostatické ovládanie radiátorových armatúr. Meranie spotreby tepelnej energie pre budovu je vykonávané objektovým meračom tepla v strojovni tepla. Výpočet tepelných strát objektu bol vykonaný v zmysle STN 06 0210 do vonkajšej teploty -15°C .

- replacement of heating system, by a divided horizontal system of distribution lines - the zone control. As the object is thermally attached to the block's boiler-room with an equithermal control of hot water, the system has been dimensioned and realized on reduced parameters by which is provided an hydraulic stability of the system (prevention from non-heating and overheating of lower/upper floors). Two mixing fittings for the zone control (north, south) MIX AP, DN 40 with electric drive are installed. As the heating system is solved by the zone control, the thermostatic controlling of radiator fittings has not been used on the heaters. Measurement of the heat energy consumption for this object is performed by the object heat gauge located in the heat machinery-room. The object's thermal losses calculation was made in accordance with STN 06 0210 up to exterior temperature -15°C .

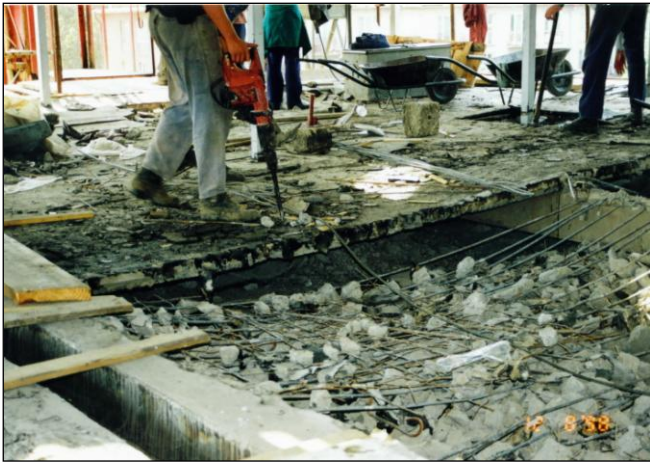
▲ Rozoberanie pôvodnej konštrukcie dvojplášťovej strechy
Dismantling of original structure of the double-jacketed roof
