## PILOTNÝ PROJEKT ODSTRÁNENIA PORÚCH

Posúdenie výskytu a návrh odstránenia systémovej poruchy obvodového plášťa a nosných stien radového bytového domu PV - 2 na Mudrochovej ulici č. 17 - 19 v Šuranoch bolo vypracované v rámci vedecko-technického projektu VTP 2811001800, etapy 02 „Obnova bytových domov konštruktívneho systému PV - 2“. V spolupráci s Občianskym bytovým družstvom Šurany bol predmetný bytový dom vybraný na realizáciu pilotného projektu. Cieľom realizácie pilotného projektu bolo potvrdenie príčiny vzniku poruchy a stanovenie nákladov na jej odstránenie.

The assessment of the occurrence and subsequent proposal for the removal of a system fault of the outer wall and load bearing walls of row dwelling house PV - 2 at Mudrochová no. 17 - 19 in Šurany was elaborated within Research-technical project 2811001800, Phase 02 “Upgrading of dwelling houses of the PV - 2 Design System.” In cooperation with the Civil Housing Co-operative of Šurany, the subject house was selected for the implementation of a pilot project. It was aimed at confirming the cause of the fault and establishing the costs of its removal.

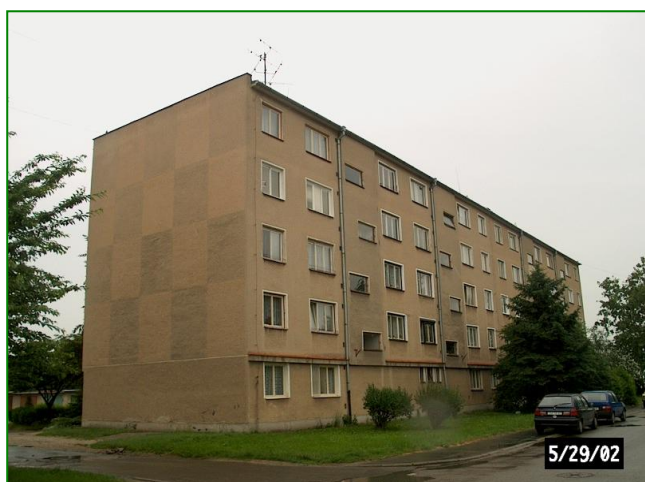
Pohľad na zadnú fasádu bytového domu – pôvodný stav  
View of the rear façade of the dwelling house – original condition

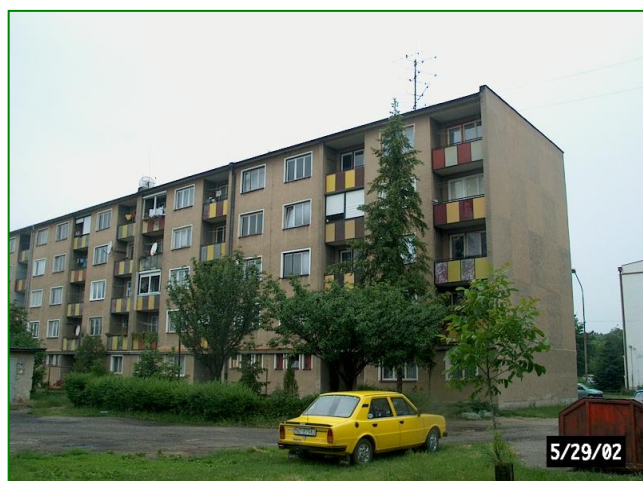
Pohľad na čelnú fasádu bytového domu – pôvodný stav  
View of the front façade of the dwelling house – original condition

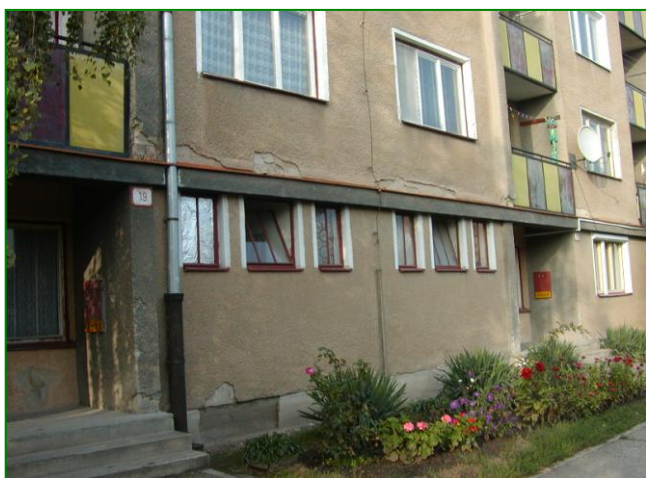
▲  
Pohľad na čelnú fasádu – vstupy do domu – pôvodný stav  
View of the front façade – entrances of the house – original condition.

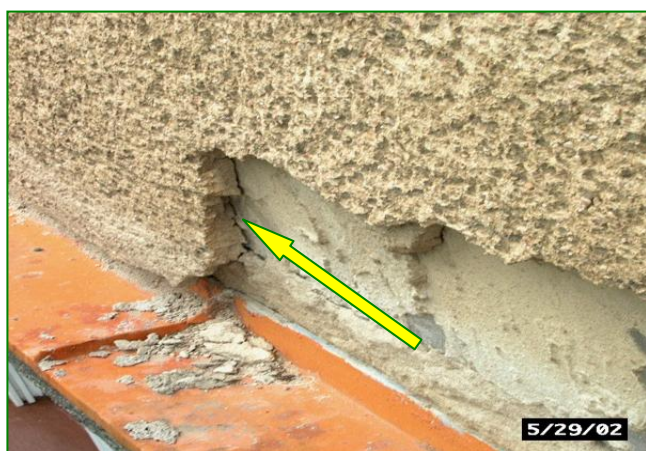
▲  
Odpadnutá a oddelená omietka hrúbky 40 mm pri rímse  
Fallen off and separated rendering with thickness of 40 mm at the moulding

Prehliadka domu potvrdila, že obvodový plášť 1. nadzemného podlažia i ďalších nadzemných podlaží (2. - 5. NP) je vymurovaný z pórobetónových tvárnic. Prieskumom vonkajších omietok na 1. NP sa potvrdilo, že brizolitová omietka je na väčšine plochy uvoľnená od podkladu. Na niektorých miestach vyšších podlaží bola brizolitová omietka odpadnutá a viditeľné bolo jej uvoľnenie na ďalších plochách od podkladu. Na povrchu sa zistili trhliny a hrúbka omietky v rozpätí 20 - 50 mm. Spôsob uvoľnenia vonkajších omietok a obnažené murivo potvrdzuje, že pred omietaním stien z pórobetónových tvárnic nebola stena dostatočne navlhčená a nebol nanesený podkladný nástrek z cementovej malty.

The inspection of the building confirmed that the outer wall of the 1<sup>st</sup> and higher storeys (2<sup>nd</sup> - 5<sup>th</sup>) was lined with porous concrete bricks. The survey of the outer rendering at the 1<sup>st</sup> storey confirmed that the brisolite rendering was, in most areas, loosened from the foundation. At some locations of the higher storeys, the brisolite rendering had fallen off and its loosening from the base was also visible in other areas. Cracks and the thickness of the rendering were in a range of 20 - 50 mm and were identified on the surface. The way in which the outer rendering had loosened, and the bared masonry, confirmed that before rendering the walls of porous concrete bricks, the wall was not sufficiently moistened, nor the base sprayed with cemented mortar. The plinth part with an altitude of 400 mm was rendered. The base layer with a thickness of approx. 15 mm was treated with bush-hammer. The base layer had a thickness of 15- 20 mm The plinth concrete had crumbled and fallen off. The rendering of the plinth was, around the entire perimeter of the building, separating from the plinth concrete. The rendering had fallen off in some spots.

Jestvujúca brizolitová omietka na vonkajšom povrchu muriva sa odstránila, prípadné väčšie nerovnosti podkladu ako 10 mm sa vyrovnali opravovacou maltou. Zateplenie sa realizovalo podľa technologického postupu platného pre použitý kontaktný zateplovací systém.

The existing brisolite rendering on the outer surface of the wall was removed, unevenness of more than 10 mm at the base was compensated with correction mortar. The insulation was implemented pursuant to the technological procedure valid for the applied contact insulation system.

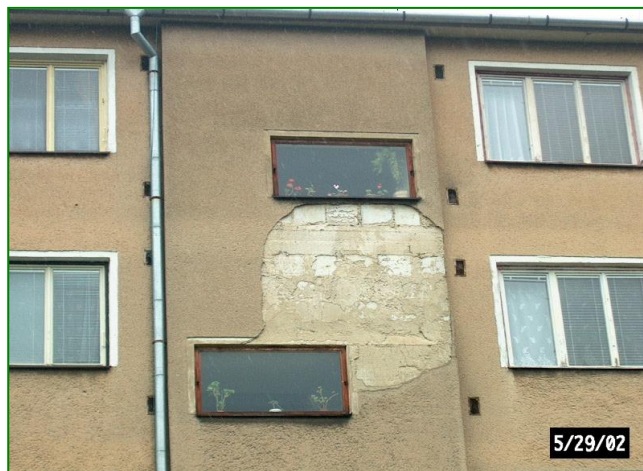
▲  
Pohľad na zadnú fasádu – odpadávajúca omietka na schodisku  
View of the rear façade – fallen rendering at the staircase

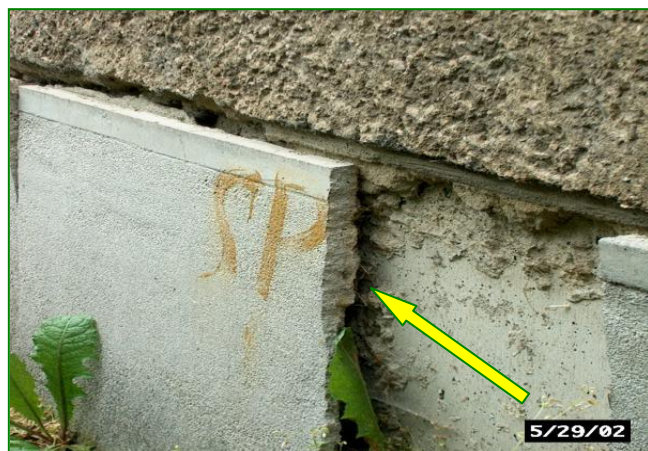
▲  
Odpadnutá a oddelená povrchová úprava sokla  
Fallen and separated finish of the plinth

Soklová časť výšky 400 mm bola omietnutá. Pohľadová vrstva približne hrúbky 15 mm sa upravila pemrlovaním. Podkladná vrstva má hrúbku 15 - 20 mm. Betón sokla sa miestami drobil a vypadal. Omietka sokla sa po celom obvode domu oddeľovala od soklového betónu. Na niektorých miestach omietka odpadla.

Na sokli sa kompletne odstránila omietka. Poškodený betón sokla sa očistil a opravil. Na zatuhnutý povrch sa naniesla nová omietka podľa technologického postupu pre nanášaný druh omietky.

The rendering was completely removed from the plinth. The damaged concrete of the plinth was cleaned and repaired. A new rendering was applied on the solidified surface pursuant to the technological procedure for the applied type of rendering.

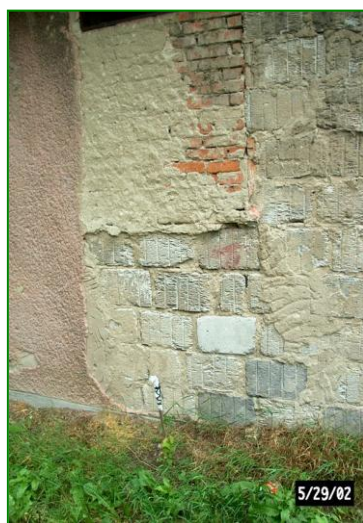
**Štítová stena.** Dom má 2 typy štítových stien: obvodové a vnútorné steny pri dilatáciách. Vonkajšia obvodová stena 1. nadzemného podlažia bola navrhnutá z tehelného muriva hrúbky 375 mm. V 2. a ďalších podlažiach je stena z pórobetónových tvárnic hrúbky 240 mm.

Štítová stena pri dilatácii v 1. NP je vymurovaná z tehál hrúbky 250 mm. Stena je v ďalších podlažiach z pórobetónových tvárnic hrúbky 240 mm. Vonkajšie omietky obvodových štítových stien boli uvoľnené od podkladu, ale neodpadávali. Vnútorné omietky na štítových stenách boli v rovnakom stave ako omietky na všetkých nosných stenách.

Rôzne druhy murovacích materiálov v štítovej stene  
Different kind of masonry materials in the gable wall

**Gabled wall.** The house has two types of gabled walls: outer and inner walls at the dilations. The outer wall of the 1<sup>st</sup> level storey was designed from brick masonry with a thickness off 375 mm. In the 2nd and other storeys, the wall was also constructed of porous concrete bricks with a thickness of 240 mm.

The gabled wall at a dilatation in the 1<sup>st</sup> storey was constructed of bricks with a thickness of 240 mm. The wall is, in the other storeys, constructed the same kind of bricks. The outer rendering of the outer gabling walls was loosened from the base but had not fall off. The inner rendering on the gabling walls was in the same shape as the rendering on all the bearing walls.

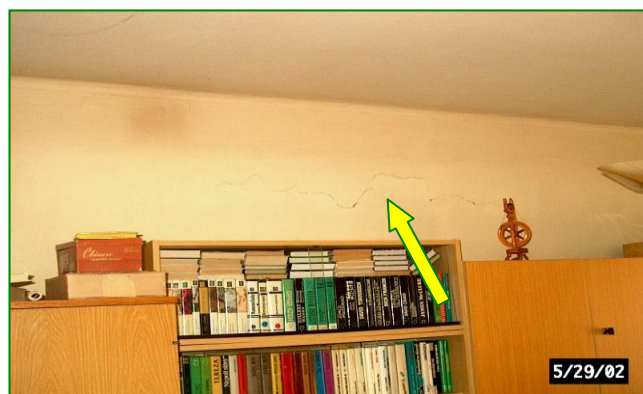
**Nosné steny.** Vnútorné nosné steny boli v 1. NP navrhnuté z tehál na šírku muriva 250 mm, vo vyšších podlažiach z pórobetónových tvárnic. Steny typického podlažia sú vymurované z pórobetónových tvárnic hrúbky 240 mm. Vizuálna diagnostikácia stien v bytoch potvrdila, že omietky na prevažnej ploche sú uvoľnené. Časť uvoľnených omietok obyvatelia odstránili a steny znovu omietli. Takto opravené omietky sa už po niekoľkých rokoch znovu uvoľňujú.

Trhliny a oddelenie vnútornej omietky od podkladu  
Cracks and separation of the inner rendering from the base

**Bearing walls.** The inner bearing walls of the 1<sup>st</sup> storey were designed of bricks with the width of the masonry being 250 mm, while in the higher storeys they were of porous concrete bricks. Walls of a typical storey were constructed of porous concrete bricks with a thickness of 240 mm. Visual diagnostics of the walls of the apartments confirmed that rendering in most areas had loosened. Part of the loosened rendering had been removed by the inhabitants, who then re-rendered the walls. Such repaired rendering had been loosening again after a few years.

Najvhodnejším spôsobom odstránenia systémovej poruchy vonkajších stien je zateplenie obvodového plášťa a na vnútorných stenách odstránenie porušenej omietky a nanosenie novej omietky s dodržaním technologických požiadaviek (navlhčenia podkladu a dodržanie hrúbok), prípadne obloženie sádkartónovými doskami.

The most suitable method of removal of the system fault was to insulate the outer wall and, on the inner walls, remove the damaged rendering and apply new rendering complying with technological requirements (moistening the base and compliance with thickness), or line it with plasterboard.

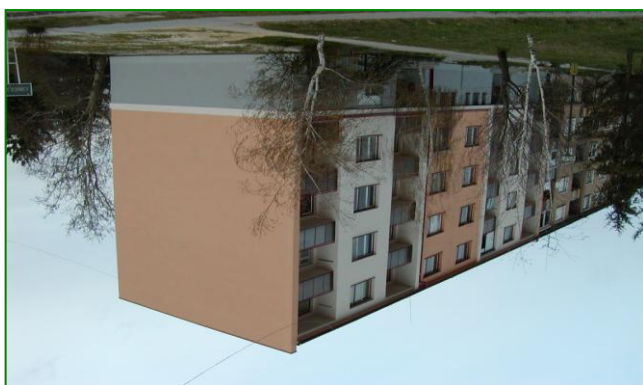
▲ Pohľad na čelnú fasádu bytového domu po zateplení  
View of the front façade of the dwelling house following the additional insulating

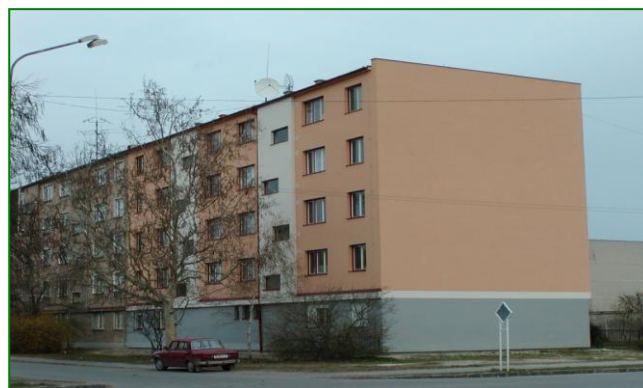
▲ Pohľad na zadnú fasádu bytového domu po zateplení  
View of the rear façade of the dwelling house following the additional insulating
